Roof Coatings Smarts: Contractor Coats Middle School Roofs

By Jennifer Frakes on 2/6/2014 4:25 PM

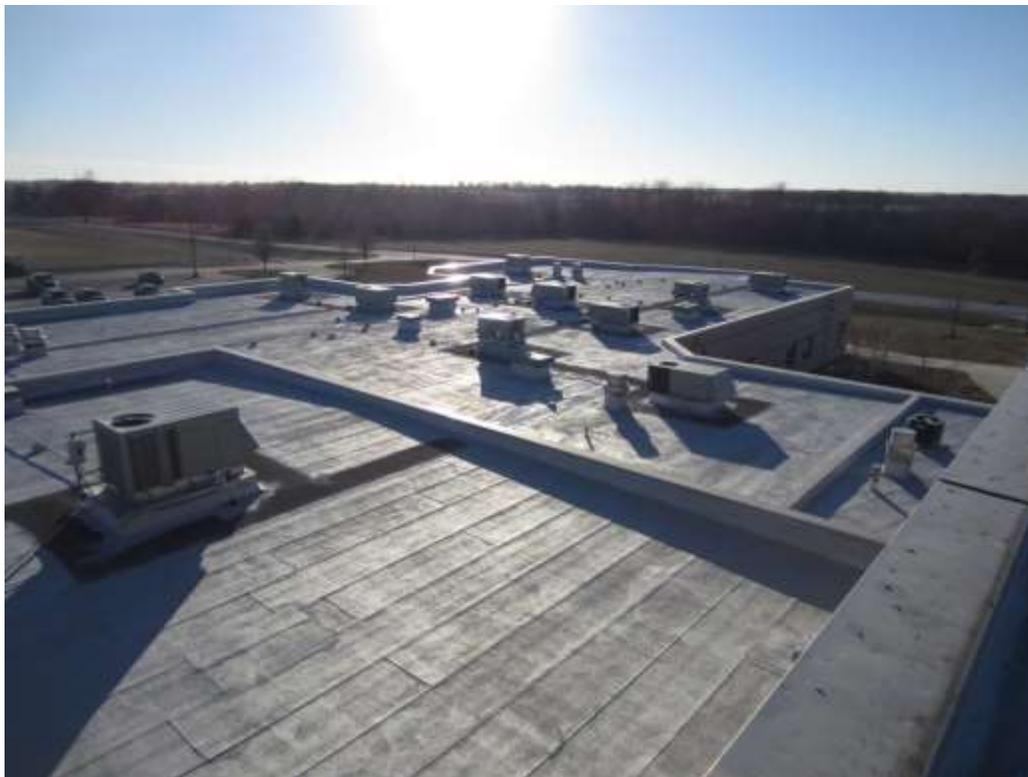
Prairie View Middle School is near La Cygne, Kan., and it serves three small towns in the rural area. The roof is approximately 50,000 square feet (4,645 m²), and the roofing substrate is white modified bitumen with granule surfacing. “After a hail storm some years ago, we inspected the roof for damage and found that everything looked good up there, but there were some loose granules,” Wilson said. “Every year during the roof survey, we found more and more loose granules, some that were starting to get into the drains. During the most recent inspection, we found that there were areas of exposed membrane.”

According to Wilson, the roof was otherwise in good shape for its age, with very few leaks. This meant that the roof did not need to be torn down and replaced, making it the perfect candidate for a coating application to restore the damaged areas and extend the life of the existing roof. “We chose Johns Manville TopGard Type A aluminum emulsion coating. It is water-based, so there were no VOC [volatile organic compound] concerns,” explained Wilson. (Johns Manville Top Gard Type A maximum VOC is 152 g/l, 1.3 lb/g).

spray tip, they applied Johns Manville TopGard Type A aluminum emulsion coating to the entire roof area at a rate of 2 gallons per 100 square feet (8 L/9 m²). This coating is a one-part roof coating that is a combination of aluminum flakes and non-asbestos reinforcing fibers suspended in emulsified asphalt. “This coating was the right choice for the job because it will protect the waterproofing components of the existing modified bitumen and extend the life of the roofing system and protect the roof from UV [ultraviolet] degradation,” said Wilson.

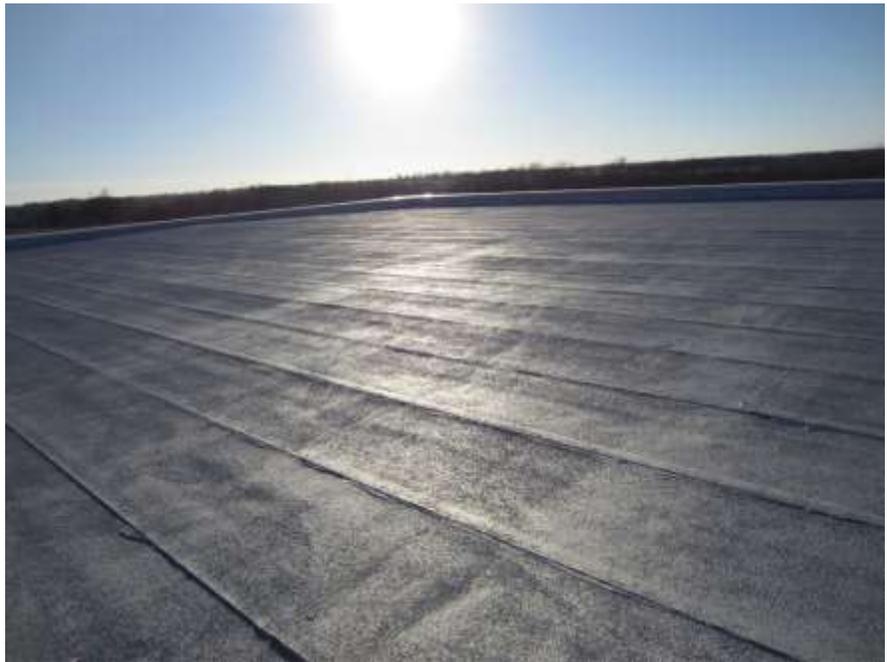
With the coating system determined, it was time for the four-man crew to get to work. Using an ECHO backpack blower and brooms, loose granules and dirt were cleaned off the roof area. The crew collected loose granules and any debris in containers and then removed them from the roof. “The roof has good slope, so there only a few low areas where we needed to apply primer,” said Wilson. In these areas, the crew used 9-inch (23 cm) rollers to apply Tamko’s Tam-Pro 813 asphalt primer.
